Date of incident:	14 September 2022
Incident #:	0069/2022
Facility:	Off site
Process/ Equipment:	Pneumatic wheel-mounted crane
Location:	Mira Str. 1, Yuzhnaya Ozereevka village, Novorossiysk

Incident resulting in property damage only

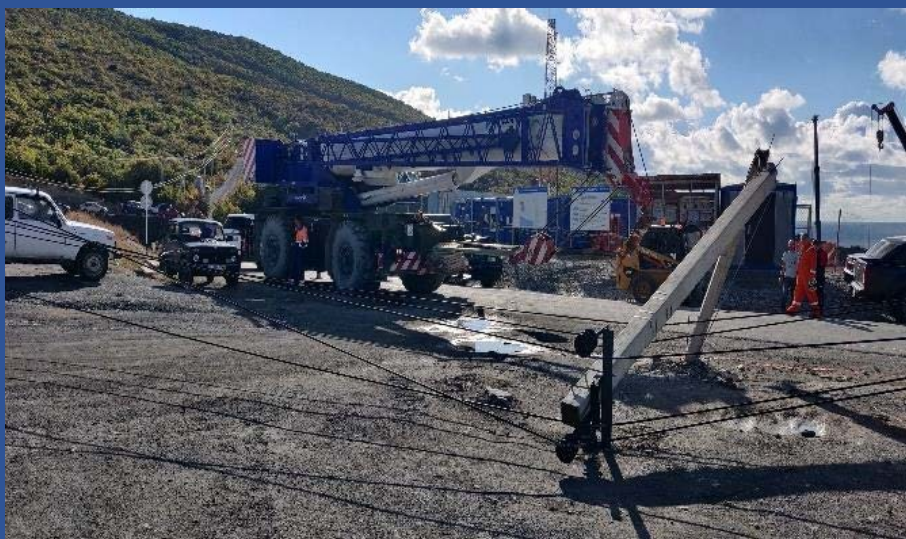
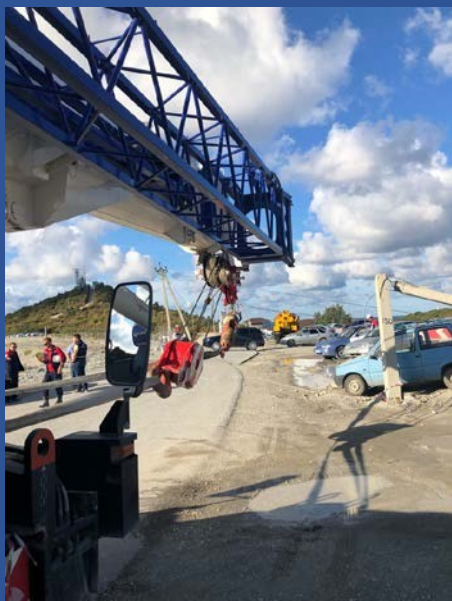
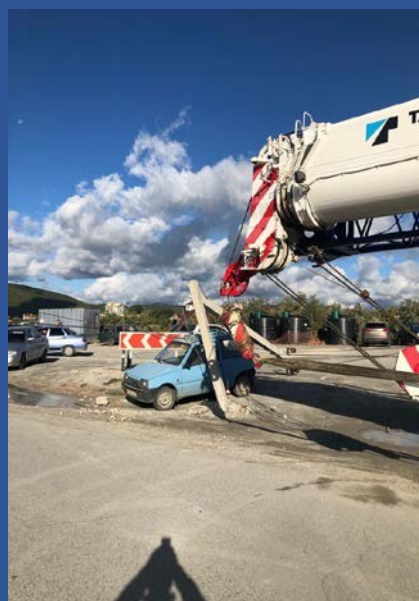
FIELD PHOTOS:

On 14.09.2022 at 08:10 a.m., pneumatic wheel-mounted crane TADANO, while parking outside LACT (DBNP) construction site at the Marine Terminal Shore Facilities, caught on Rosseti Kuban PJSC South-West Power Grid owned overhead power line (OHPL) pole with its boom. The contact resulted in OHPL pole collapsing and falling on the ground, electrical grid wires were broken. Three OHPL poles were damaged and some part of Yuzhnaya Ozereevka village was blacked out as a result of the incident. Special vehicles incurred no mechanical damage. Nobody was injured. The incident caused only property damage of the equipment of third party organization not being part of hazardous industrial facility.

- Planning, risk management:
 - Improper maintenance planning, lack of clear plan for lifting equipment maintenance procedure and process
- Training/ Competence:
 - Poor level of knowledge of the applicable requirements of procedures and instructions
 - Crane Operator while pulling up and parking missed the fact that there is auxiliary jib attached to the side surface of the boom behind the main crane boom.
 - Lack of Contractor's approved on-the-job training program for Tadano crane operators

- Prior to the work, provide for delivery of a job specific briefing for WTLs, operators, mechanical engineers on managing safe movement at the job site and outside construction sites, including training log records.
- For movement of large vehicles and special equipment, ensure that the requirement for mandatory banksman support is included in Permit to Work.
- Organize an unscheduled training of the personnel appointed as banksmen in the training course "CPC 306. Banksman Training" in the OlympOKS-Enterprise system
- Consider the option of marking the power line poles located on the roadway and in the area of large vehicles and special equipment movement with additional warning signs.
- DBNP Contractor and its Subcontractors to ensure availability of approved crane operator on-the-job training programs, and completion by operators of on-the-job training before admission to work
